Tuesday, June 5, 2018
BWRMA Road Inspection

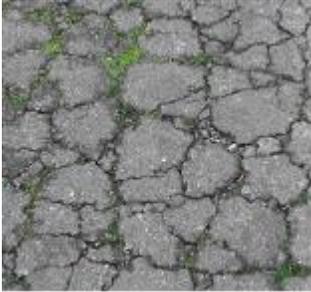
Please note that “AG” throughout the report below stands for aligating. It is a cracking of the surface that looks like this:
